Paper No.  
**09329**

**PERFORMANCE OF COMPOSITE MATERIALS IN CORROSIVE CONDITIONS: CATHODIC  
DISBONDMENT OF COMPOSITE MATERIALS AND MODELING OF A COMPOSITE REPAIR  
PATCH FOR PIPELINES**

D. Hill, A. Ertekin, N. Sridhar  
Det Norske Veritas Research and Innovation – USA  
5777 Frantz Rd  
Dublin, OH 43017

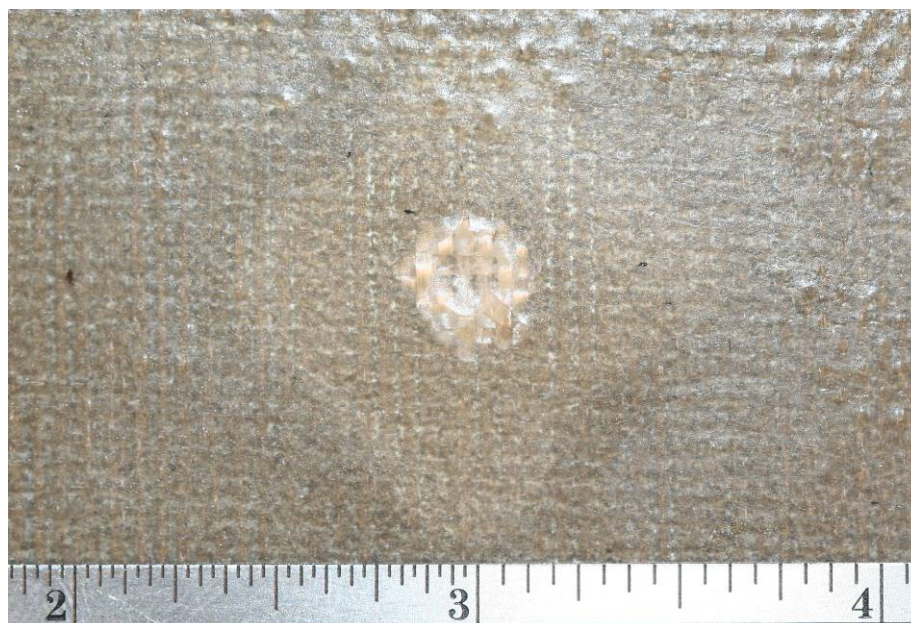
**FIGURE 1** The impact to the glass fiber reinforced polyester caused noticeable deformation around the impact site, as shown in this photograph. Scale is in inches.

tube such that impacts with the surface were uniform and repeatable. A representative impacted specimen is shown in FIGURE 1, where the E-glass impact is shown in the center of the figure. After impact, the specimen was tested for conductivity per ASTM G62 to determine whether the impact penetrated to the substrate<sup>12</sup>. The conductivity test used a wet sponge at the end of a wand, with a DC voltage applied between the end of the wand and the substrate. The substrate was connected via an electrode clamp. If the impact penetrated the composite material, water from the sponge on the wand created a conductive path into the holiday (defect) and to the substrate. If conductivity was achieved, the system emitted an audible signal. Specimens were tested with this method to assess whether the impact penetrated to the substrate, because visual observation of impact depth can be misleading.

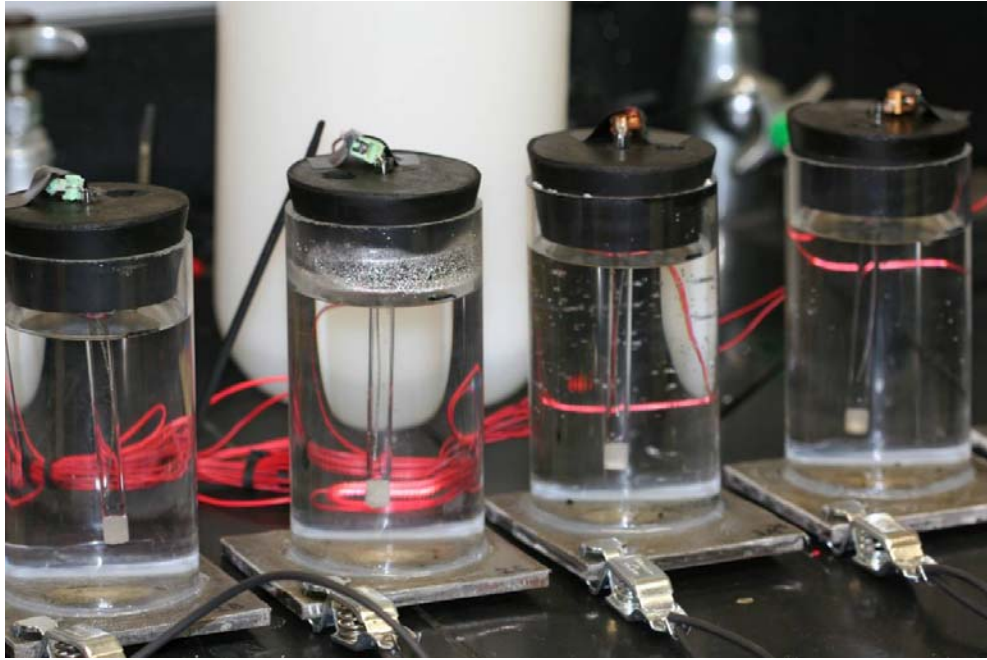
**FIGURE 2** The cathodic disbondment cells are shown in the photo, attached to the composite plates via silicone adhesive.

Cathodic disbondment was performed at room temperature via an attached cell method per ASTM G95<sup>13</sup>. The ASTM G95 standard was originally intended for evaluating cathodic disbondment of coatings with drilled holidays. In this case the standard was modified to evaluate CD performance of composite materials (instead of coatings) with an impact site (instead of a drilled defect). An acrylic cell centered about the defect site was affixed to the surface of the composite with a silicone adhesive. Once secured, the cell was filled with a 3% NaCl solution. A platinum wire was inserted into the solution inside a frit, and a 3V DC potential (vs. a saturated calomel reference electrode) was applied between the platinum and the steel plate onto which the composite was adhered. The cathodic disbondment cells are shown in FIGURE 2.

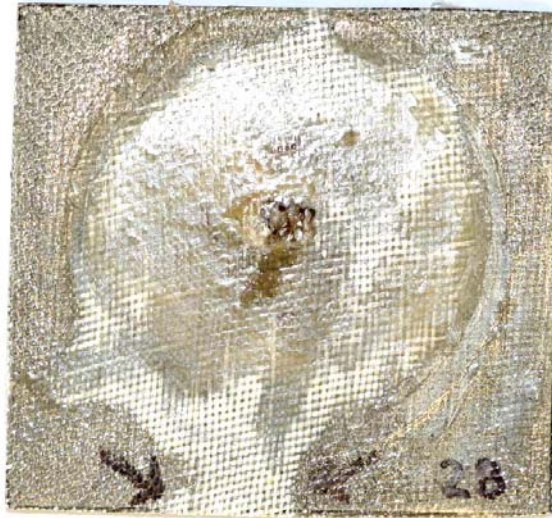
**FIGURE 4** Photographic views of glass fiber reinforced polyester composites exposed to a cathodic disbondment cell show (a) the entire test area illustrating evidence of dissolution of the polyester matrix with the presence of localized dry fiber areas, and (b) a close-up of the polyester matrix dissolved beyond the cathodic cell.

Specimens with one layer of fiberglass began to fail after 30 days of cathodic disbondment testing. Other specimens failed within the testing period with a maximum time of 90 days. If the specimen passed the ASTM G62 holiday detection test, in most cases it would eventually develop full penetration at the impact site. When failures were observed, the failure was first characterized by leaking of the test solution at the composite-steel interface at the edge of the plate. Subsequent evaluation revealed the dissolution of the polyester matrix in the majority of the exposed area and sometimes beyond, as shown in FIGURE 4. In most cases, total disbondment was achieved.

As shown in the figure, the disbondment process led to adhesion loss at both the steel substrate and between layers. This kind of behavior was evident for all materials that failed the ASTM G62 screening test. All specimens with less than 3 layers of material failed the ASTM G62 test. Few of the specimens passed the G62 qualification procedure, and if a holiday was not initially detected, these specimens eventually developed a fully penetrated holiday during the test. Most began to show failure within 30 days. Some carbon fiber and aramid materials were permitted to run beyond 30 days to investigate longevity and resistance to degradation. It should be noted that carbon fiber is conductive, and even with a thick matrix layer applied first to the substrate, the carbon fiber managed to establish a conductive path with the steel substrate in all cases. As a result, during the ASTM G95 test, the carbon fiber shows evidence of gas evolution in locations besides the impact site. In some cases the resulting dissolution of the matrix was evident in locations besides the impact site. Gas evolution was witnessed at multiple locations on the carbon fiber as shown in FIGURE 5 (taken during an active test through the acrylic cell).

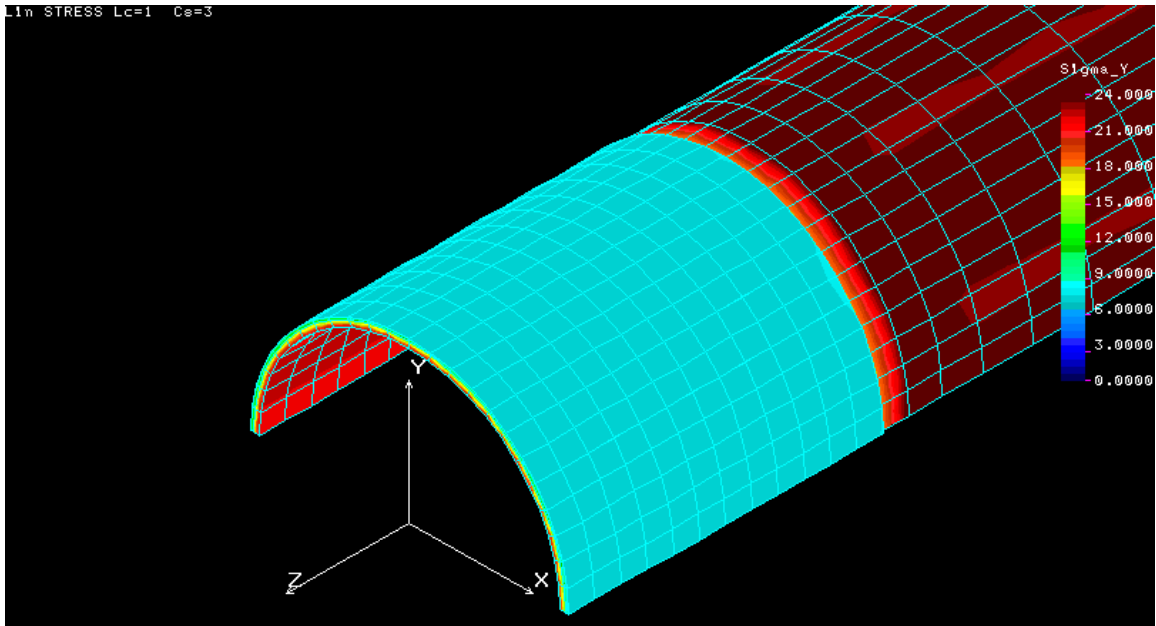
**FIGURE 9** A contour plot of the hoop stress in one of the 3D steel pipe-composite repair models, with a full encirclement repair. Stress is measured in ksi.

FIGURE 9 is a contour plot of the hoop stress in the 3D model of the steel pipe with a full encirclement composite repair sleeve. The model is a quarter-model of the pipe and repair, so horizontal (X-Z) and vertical (X-Y) mirror symmetry planes can be assumed, as illustrated previously in FIGURE 3. The left side (open end) of the model represents the reinforced section of pipe. The stress in both the reinforced section of pipe and the composite repair are less than in the un-reinforced section of pipe. Stress in the composite is lowest in regions near the center of the repair, far from the edges. The low stress in the reinforced section of pipe is indicated by the gradient to be lowest near the outer diameter. The higher stress in the un-reinforced section of the pipe is indicated by the gradient to be maximum near the inner diameter and is comparable to the calculated nominal hoop stress one would expect in an undamaged pipe. In addition, there is a reduction in hoop stress in the un-reinforced section of pipe near the axial edge (right side) of the composite repair. This is due to the geometry and internal loading. The model is appropriate to consider the generic stress distribution in a steel pipe with full encirclement sleeve.

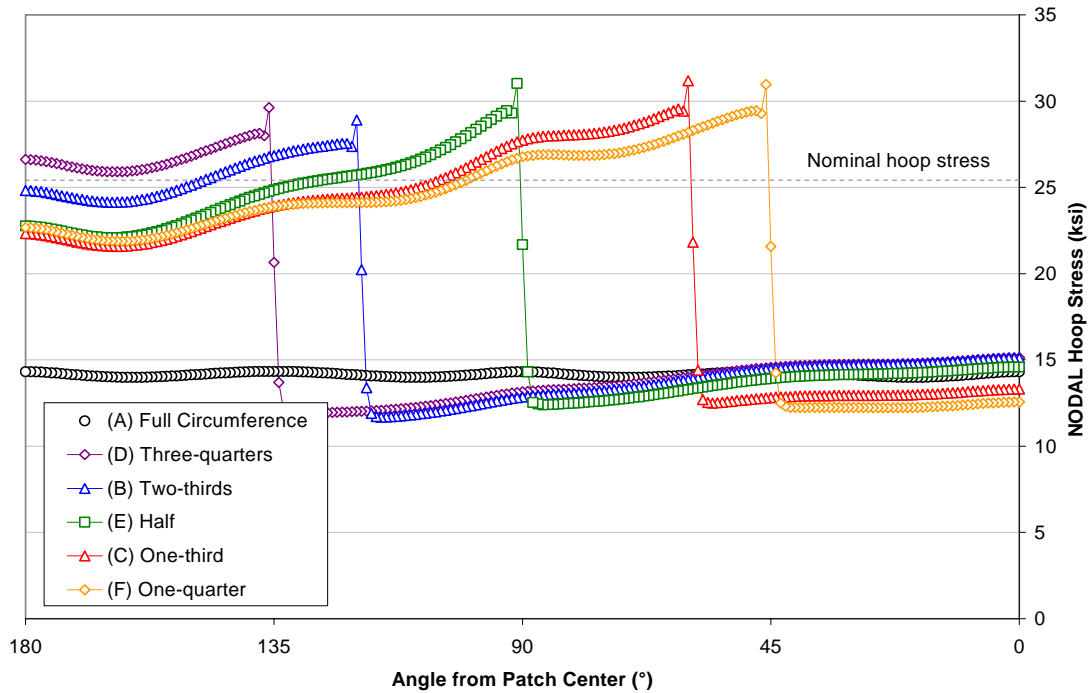
**FIGURE 12** A plot of the nodal hoop stresses calculated along the external surface of the pipe model for six different models, as a function of location along the circumference of the pipe.

FIGURE 12 a plot of the nodal hoop stresses calculated along the external surface of the pipe for six different models as a function of location along the circumference of the pipe. The data in FIGURE 12 corresponds to the angular coordinate geometry in FIGURE 3. The data points on the right side of the plot represent an average hoop stress, effectively an average of the stresses borne by the steel pipe and the composite repair. The data points on the left side of the plot represent the hoop stresses along the external surface of the un-reinforced section of pipe. Note that the length of the right and left sections vary with circumferential extent of repair. The grey dashed line indicates the nominal hoop stress in an equivalent un-reinforced pipe. There is a fluctuation in the stresses in the un-reinforced pipe that can be disregarded. These fluctuations are due to a slight faceting of the pipe model, as flat elements are made to conform to a circular geometry. FIGURE 12 shows that partial circumference reinforcement of a pipe with a composite repair will lead to stresses greater than the prescribed nominal hoop stress near the circumferential limit of the patch. Elsewhere the reinforcement provides adequate strength such that the hoop stress is below the nominal hoop stress without reinforcement.
