Flaw Analysis of a Gas Scrubber

Anomalies were discovered in the heads of two inlet separator vessels during a routine ultrasonic inspection. DNV was asked to assess the flaws and to determine if repair was necessary. Assessments were performed according to API 579 and used as a basis for fitness-for-service assessments. The flaws were found to be acceptable and costly repairs were avoided.

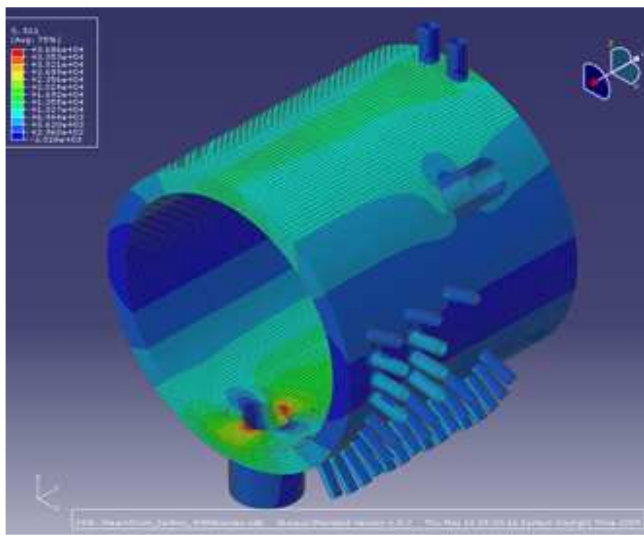
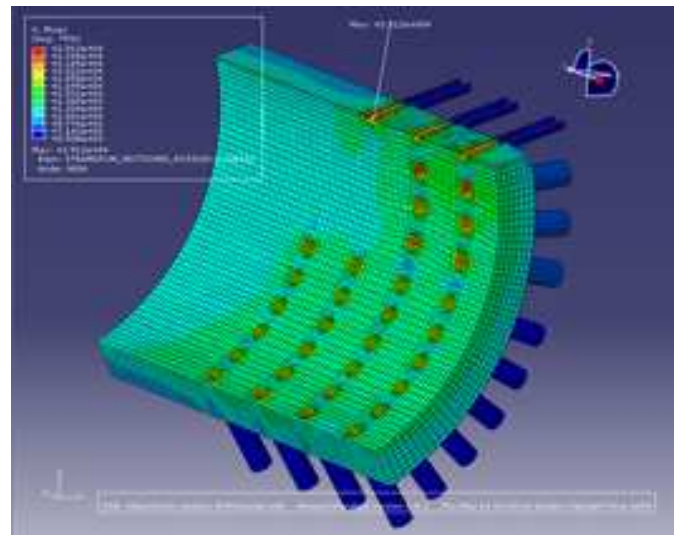
DNV performed Level 1/Level 2 assessments from the API Recommended Practice 579 on four of the flaws using finite element analysis. Due to the sensitive location of the fifth flaw, which was close to the nozzle, a Level 3 analysis was employed using finite element analysis (Level 1/Level 2 assessments are not acceptable practices for that location). Finite element analysis was used to calculate stresses, which were used as a basis for a fitness-for-service assessment. From the assessment, it was concluded that the flaw was acceptable for service by Level 3 criteria.
